**Nissan North America, Inc., and Nissan Motor Company, LTD.**

**Investigation and Failure Analysis: Vehicle Floor Pan Corrosion  
Nissan L31 Altima (MY 2002-2006) and A34 Maxima (MY 2004-2008)**

**Report prepared by:  
Anand David Kasbekar, Ph.D.  
VSI File No. 1699  
October 12, 2018**

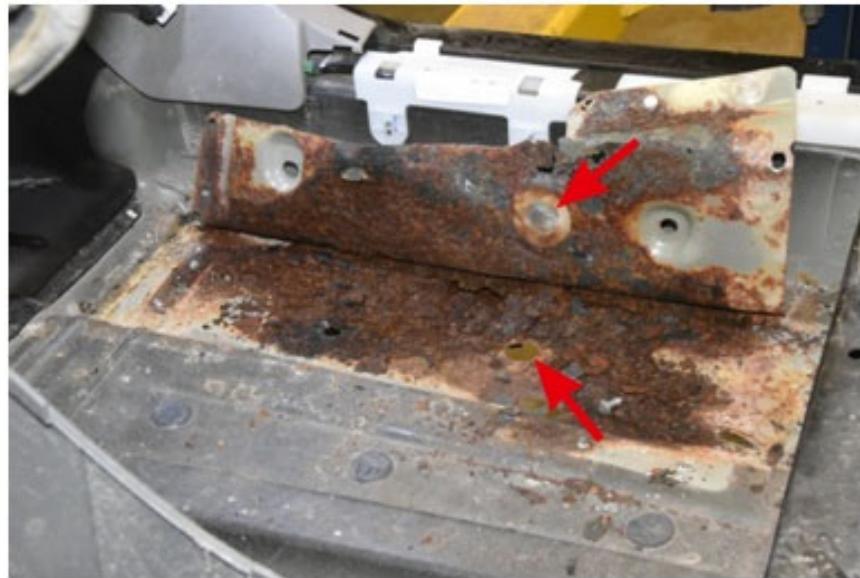
**Figure 2:** Passenger side floor pan of inspected Nissan Altima manufactured in June of 2004 after partial removal of upper reinforcing structural member. The arrows indicate the previously discussed concentric holes. The upper arrow shows the butyl patch that was placed on the top surface of the reinforcing member. This corrosion is not visible from inside the vehicle until removal carpet/damping layers and removal of the reinforcing member.

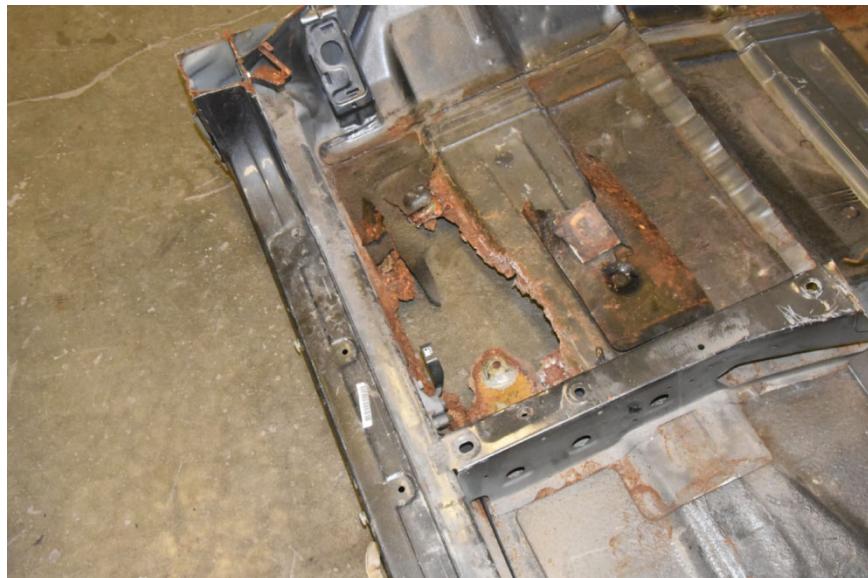
**Figure 3:** Driver side floor pan of inspected Nissan Altima manufactured in March of 2005. Note the large through hole adjacent to the fuel door release latch.

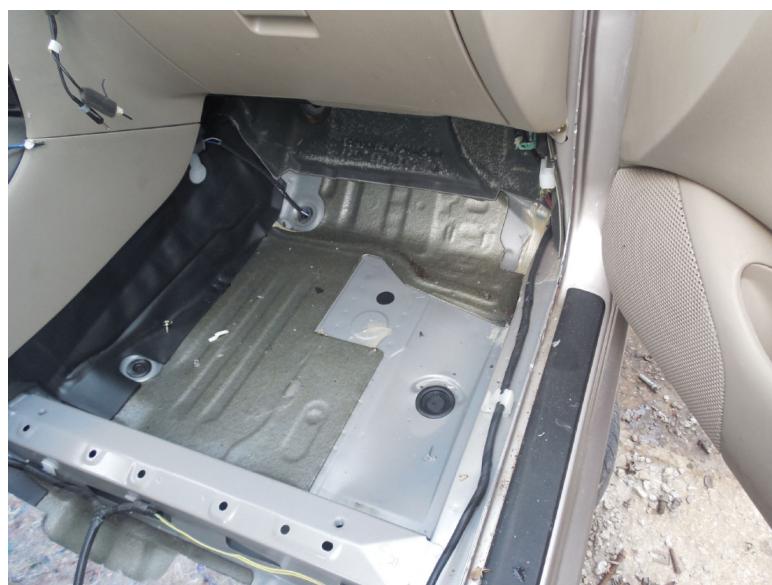
**Figure 10: 2016 Photograph of plastic plug seal in 2003 Toyota Corolla floor pan. Note absence of corrosion or evidence of moisture intrusion.**

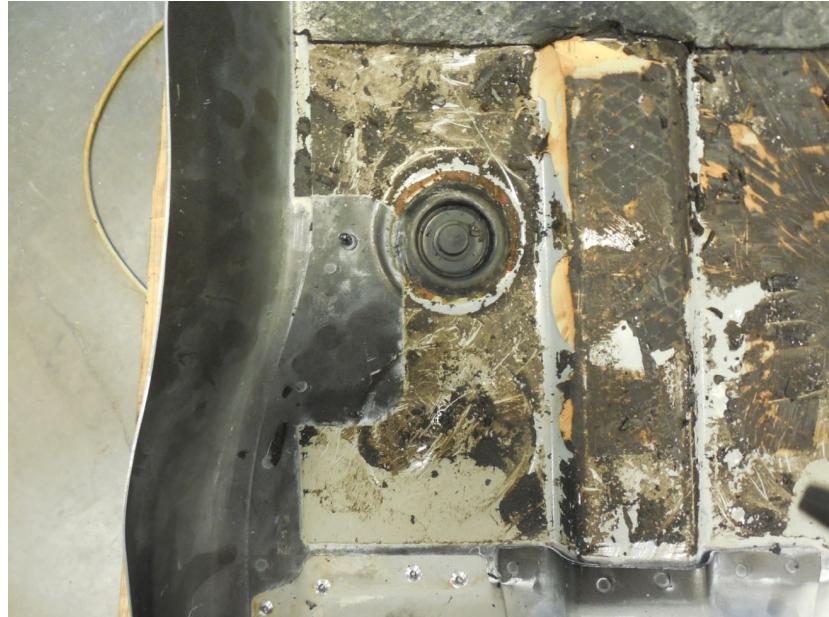
**Figure 11:** 2016 photograph of plastic plug seal from of 2002 Volkswagen Golf floor pan. Note absence of any corrosion or evidence of moisture intrusion.

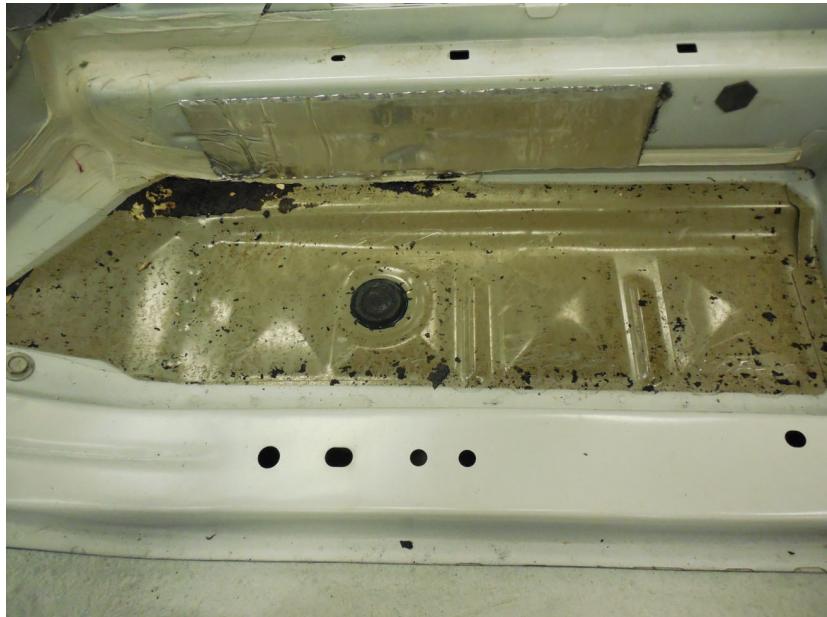
**Figure 13:** 2016 photograph of plastic plug seal from newer 2009 Nissan Altima floor pan. Note absence of any corrosion or evidence of moisture intrusion in contrast to Altimas from subject vehicle class.

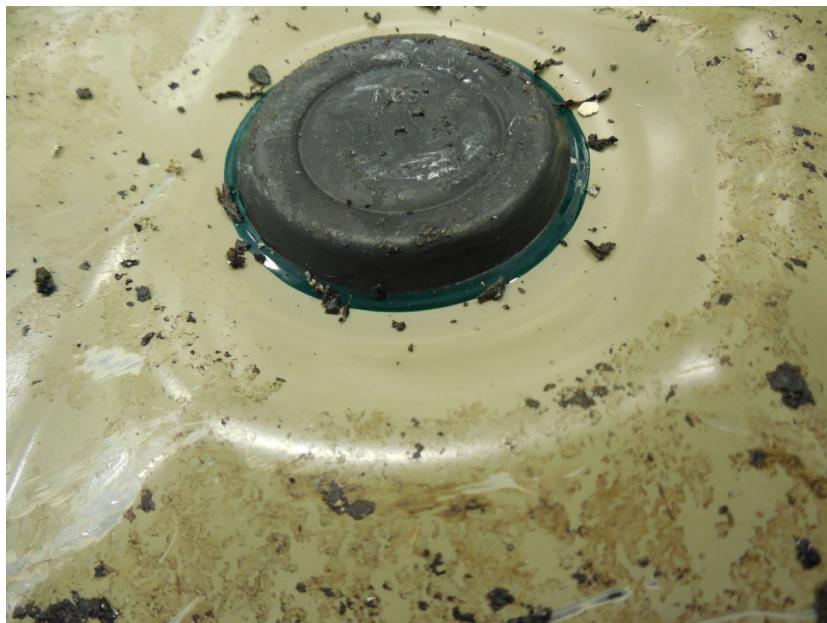
**Figure 14:** Close-up photograph of plastic plug seal shown in Figure 13. Note absence of any corrosion or evidence of moisture intrusion in contrast to Altimas from subject vehicle class.
